NASA/TP-97-206257

The Characteristics of Fatigue Damage in the Fuselage Riveted Lap Splice Joint

Robert S. Piascik
Langley Research Center, Hampton, Virginia

November 1997

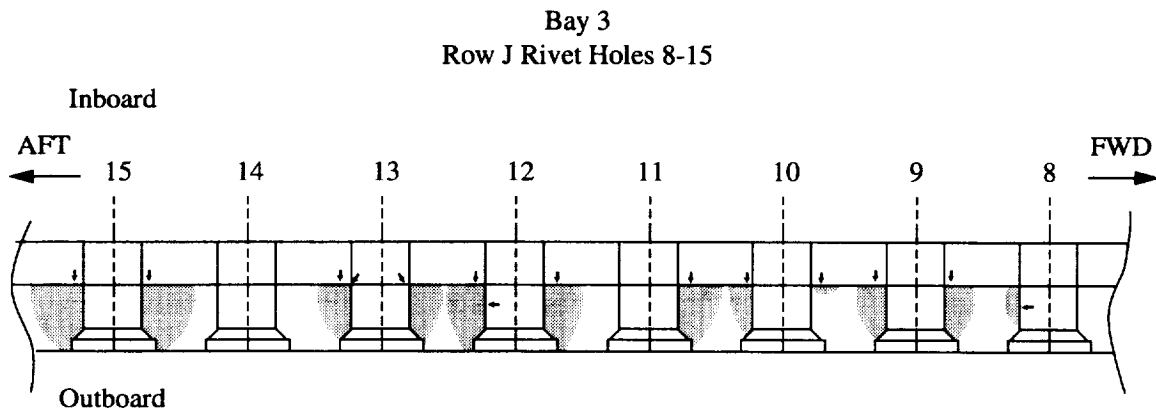
Hole #	Location	Length mm (in)	Type	Initiation site
8 (Aft)	Outer Skin	0.742 (0.029)	Countersink	Center of shank
9 (Aft)	Outer Skin	1.737 (0.068)	Countersink	Inner skin / outer skin
9 (Fwd)	Outer Skin	1.130 (0.044)	Countersink	Inner skin / outer skin
10 (Aft)	Outer Skin	0.905 (0.036)	Countersink	Inner skin / outer skin
10 (Fwd)	Outer Skin	0.307 (0.012)	Fretting	Inner skin / outer skin
11 (Fwd)	Outer Skin	4.160 (0.164)	Countersink	Inner skin / outer skin
12 (Aft)	Outer Skin	3.220 (0.127)	Through	Multiple sites
12 (Fwd)	Outer Skin	4.890 (0.192)	Through	Inner skin / outer skin
13 (Aft)	Outer Skin	2.030 (0.080)	Countersink	Multiple sites
13 (Fwd)	Outer Skin	2.500 (0.098)	Countersink	Inner skin / outer skin
15 (Aft)	Outer Skin	3.040 (0.120)	Through	Inner skin / outer skin
15 (Fwd)	Outer Skin	2.980 (0.115)	Through	Inner skin / outer skin

Figure 9.5 The through thickness schematic shows the location and initiation site of fatigue cracks found in rivet row J (holes 8-15) of bay 3. The table summarizes crack location, crack length, crack type, and initiation site for each fatigue crack shown.

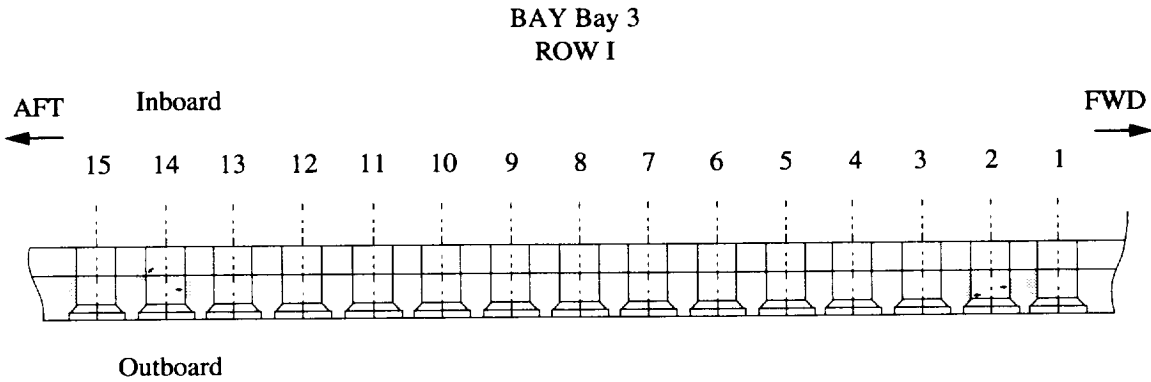
Hole #	Location	Length mm (in)	Type	Initiation site
1 (Aft)	Outer Skin	Not determined	Countersink	Not determined
2 (Aft)	Outer Skin	0.336 (0.013)	Countersink	Outboard side of shank
2 (Fwd)	Outer Skin	0.088 (0.003)	Countersink	Center of shank
14 (Aft)	Outer Skin	0.084 (0.003)	Countersink	Inboard side of shank
14 (Fwd)	Outer Skin	0.174 (0.007)	Countersink	Center of shank
15 (Aft)	Outer Skin	0.148 (0.006)	Countersink	Center of shank

Figure 9.6 The through thickness schematic shows the location and initiation site of fatigue cracks found in rivet row I of bay 3. The table summarizes crack location, crack length, crack type, and initiation site for each fatigue crack shown.

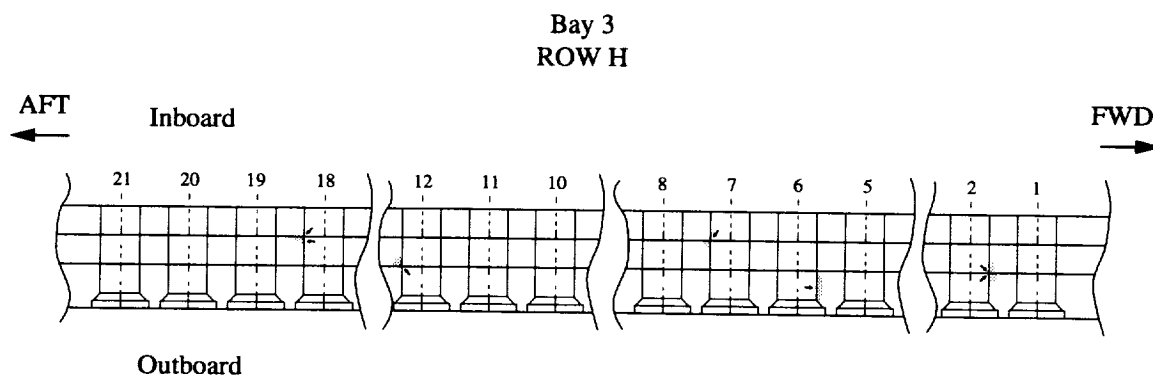
Hole #	Location	Length mm(in)	Type	Initiation site
2(1 Fwd)	Inner skin	0.246 (0.010)	Corner	Outboard corner
2(2 Fwd)	Outer skin	0.055 (0.002)	Countersink	Inboard corner of shank
6(Fwd)	Outer skin	0.125 (0.005)	Countersink	Center of shank
7(Aft)	Inner skin	0.183 (0.007)	Corner	Inboard corner
12(Aft)	Inner skin	0.170 (0.007)	Corner	Outboard corner
18(Aft)	Inner skin	0.184 (0.007)	Corner/surface	Corner and surface

Figure 9.7 The through thickness schematic shows the location and initiation site of fatigue cracks found in rivet row H of bay 3. The table summarizes crack location, crack length, crack type, and initiation site for each fatigue crack shown.

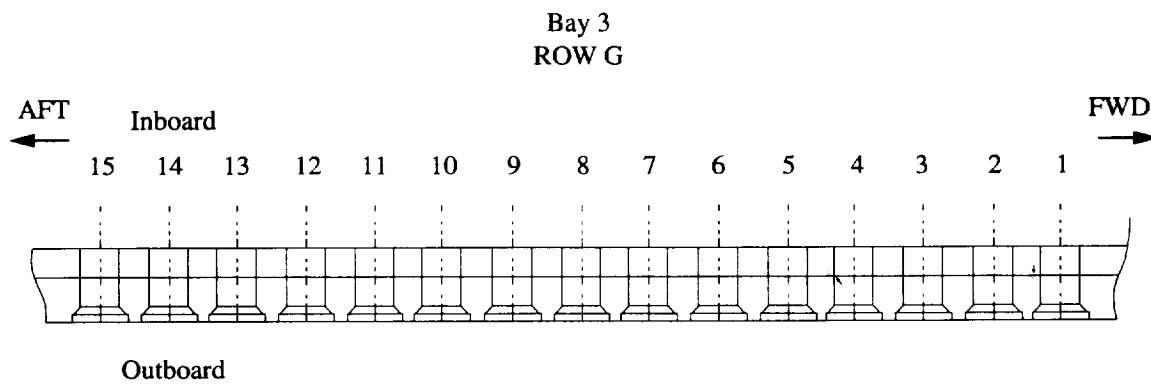
Hole #	Location	Length mm(in)	Type	Initiation site
1(Aft)	Countersink	0.091 (0.004)	Fretting	Inner skin/outer skin
4(Aft)	Inner skin	0.120 (0.005)	Corner	Outboard corner

Figure 9.8 The through thickness schematic shows the location and initiation site of fatigue cracks found in rivet row G of bay 3. The table summarizes crack location, crack length, crack type, and initiation site for each fatigue crack shown.

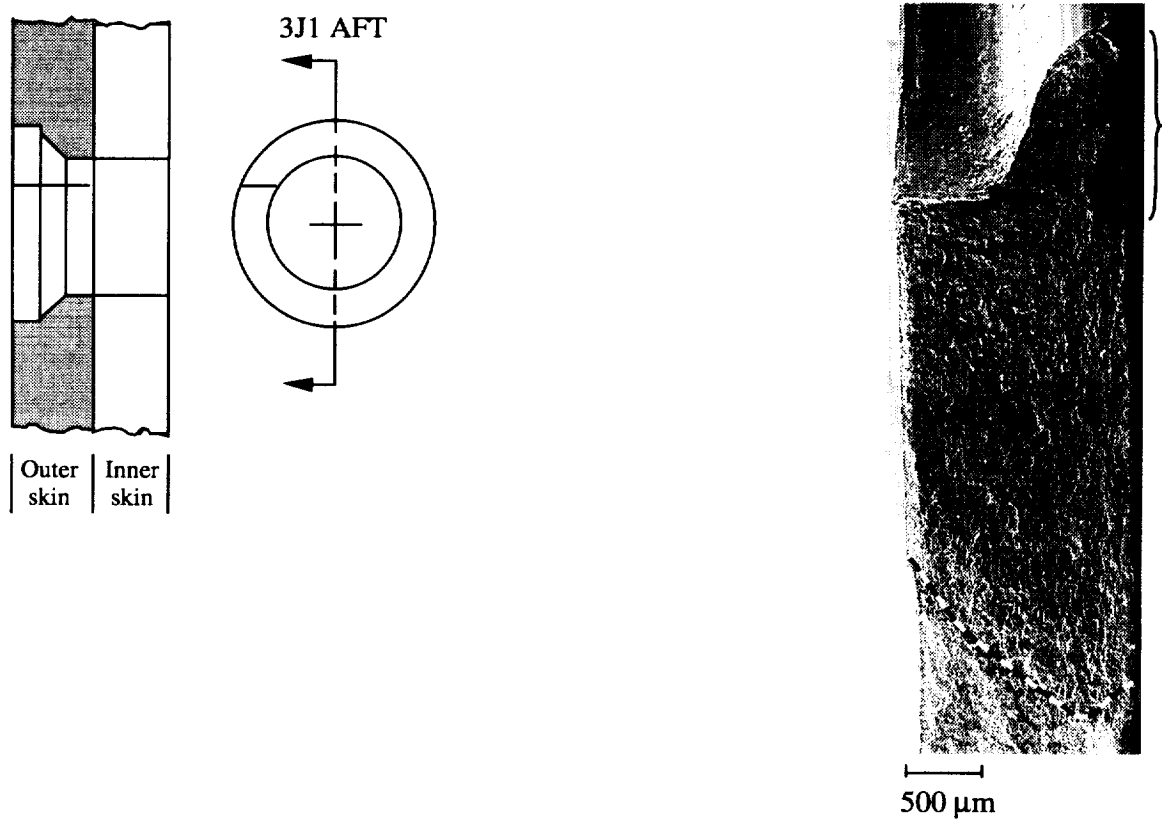
Figure 9.9 a) The schematic shows the rivet hole 3J1 configuration and the location of the outer skin fatigue crack oriented in the aft direction and about the 10 o'clock position. b) The SEM micrograph shows the through-thickness fatigue crack and the rivet hole (top). The bracket shows the likely crack initiation region along the faying surface and the dashed line marks the fatigue crack front. Considerable oxide was noted in the region of crack initiation.

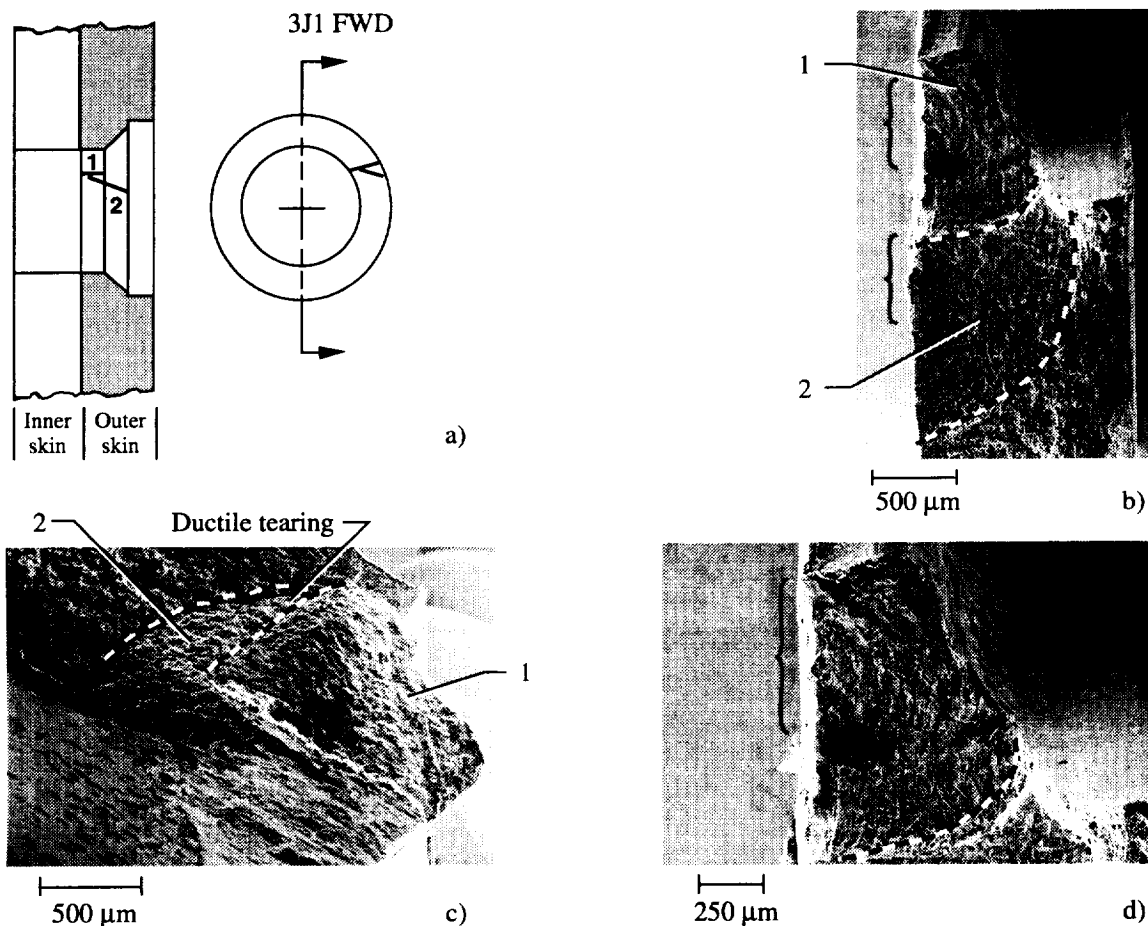
Figure 9.10 a) The schematic shows the rivet hole 3J1 configuration and the location of two outer skin fatigue cracks oriented in the forward direction and about the 2 o'clock position. b) The SEM micrograph shows the fracture surface of two (1 & 2) fatigue cracks and the rivet hole (top). The dashed lines mark both fatigue crack fronts. Brackets identify the crack initiation regions of both cracks along the faying surface. c) The SEM micrograph shows the fatigue fracture surface at an oblique angle. The dashed line marks a region of ductile tearing, suggesting that a portion of the crack fronts had not joined until this region was destructively examined. d) The SEM micrograph shows the fracture surface of crack #1 and the region of crack initiation (bracket) at higher magnification.

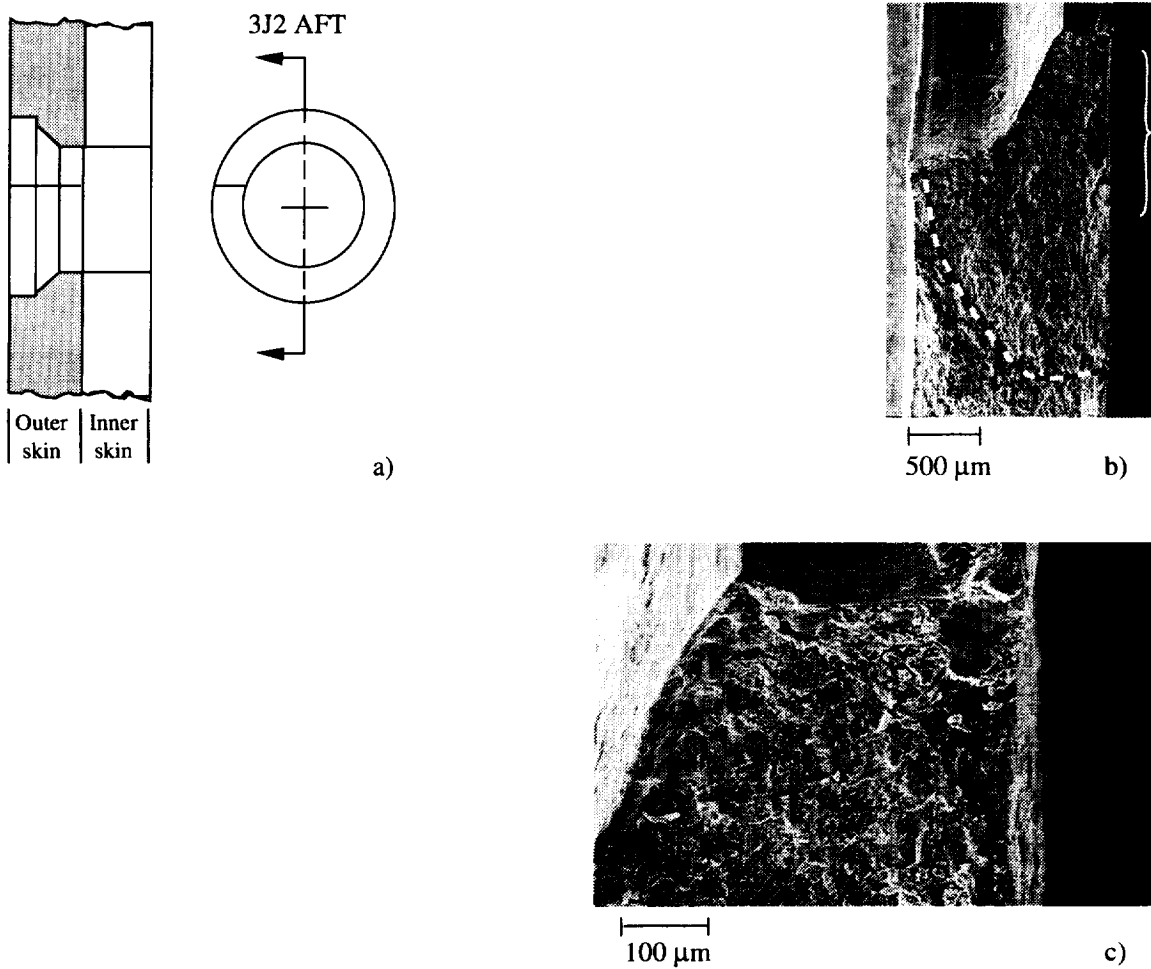
Figure 9.12 a) The schematic shows the rivet hole 3J2 configuration and the location of the outer skin fatigue crack oriented in the aft direction and about the 10 o'clock position. b) The SEM micrograph shows the through-thickness fatigue crack and the rivet hole (top). The bracket shows the likely crack initiation region along the faying surface and the dashed line marks the fatigue crack front. c) The SEM micrograph shows the rivet hole shank region at higher magnification.

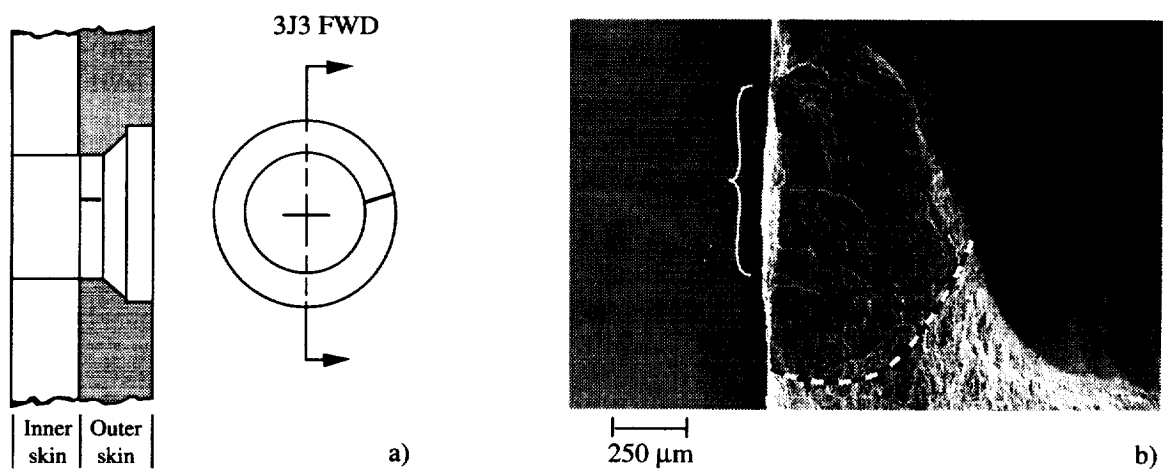
Figure 9.13 a) The schematic shows the rivet hole 3J3 configuration and the location of the outer skin fatigue crack oriented in the forward direction above the 3 o'clock position. b) The SEM micrograph shows the fatigue crack located at the rivet hole. The bracket shows the likely crack initiation region along the faying surface and the dashed line marks the fatigue crack front.

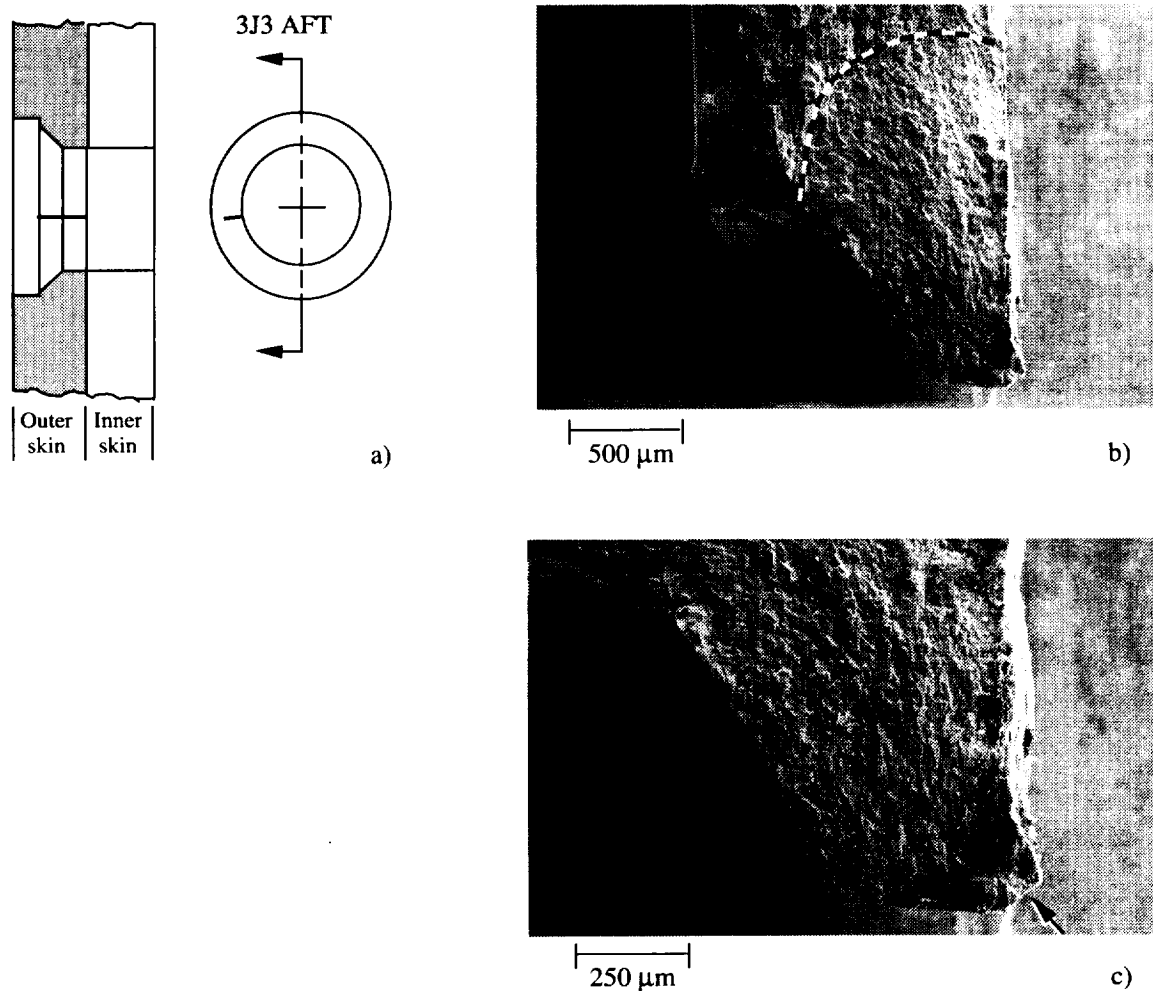
Figure 9.14 a) The schematic shows the rivet hole 3J3 configuration and the location of the outer skin fatigue crack oriented in the aft direction below the 9 o'clock position. b) The SEM micrograph shows the fatigue crack located at the rivet hole. The dashed line marks the fatigue crack front. c) The SEM micrograph shows the fatigue crack fracture surface at the rivet hole shank region. The arrow marks the likely region of crack initiation at the inboard corner of the rivet hole.

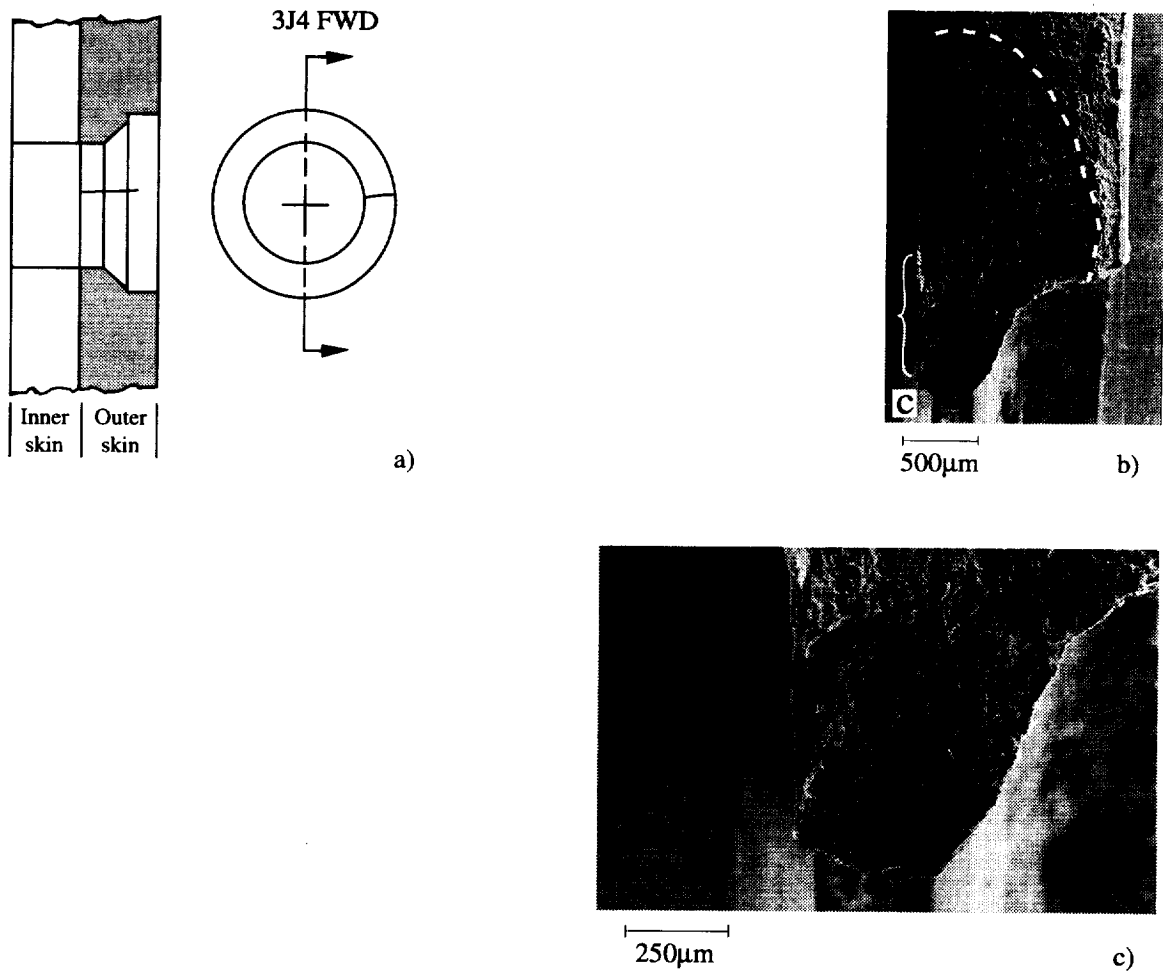
Figure 9.15 a) The schematic shows the rivet hole 3J4 configuration and the location of the outer skin fatigue crack oriented in the forward direction above the 3 o'clock position. b) The SEM micrograph shows the fatigue crack at the rivet hole (bottom). The bracket shows the likely crack initiation region along the faying surface and the dashed line marks the fatigue crack front. c) The SEM micrograph shows the fatigue crack fracture surface at the rivet hole shank region.

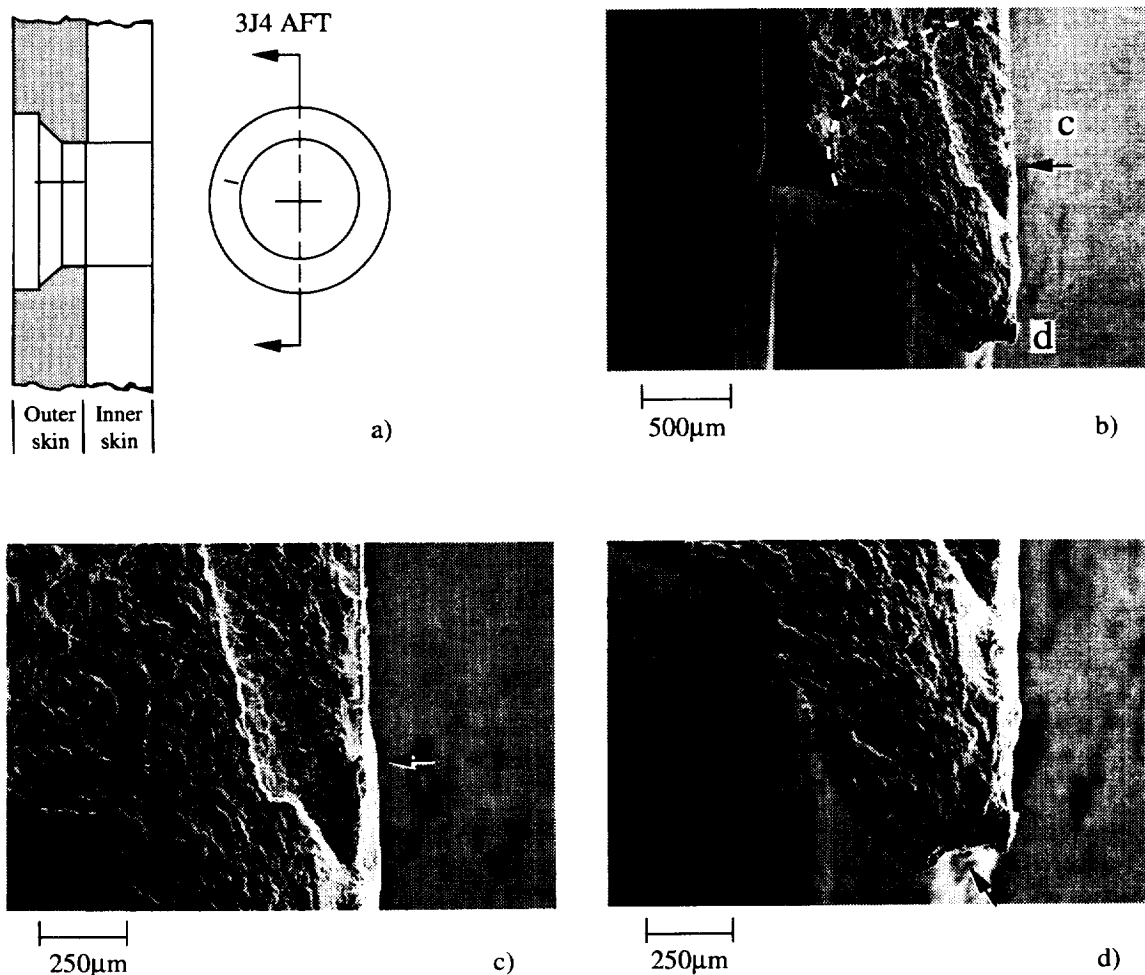
Figure 9.16 a) The schematic shows the rivet hole 3J4 configuration and the location of the outer skin fatigue crack oriented in the aft direction and about the 10 o'clock position. b) The SEM micrograph shows the fatigue crack at the rivet hole (bottom). The micrograph reveals that cracking occurred along two fracture planes ("c" and "d"). An arrow marks the likely crack initiation region for crack "c" along the faying surface. The dashed line marks the fatigue crack front. c) The SEM micrograph shows the fatigue crack surface at region "c". The arrow marks the likely crack initiation site along the faying surface. d) The SEM micrograph shows the fatigue crack surface at the rivet hole shank region "d" in Figure 9.16.b. The arrow marks the likely region of crack initiation.

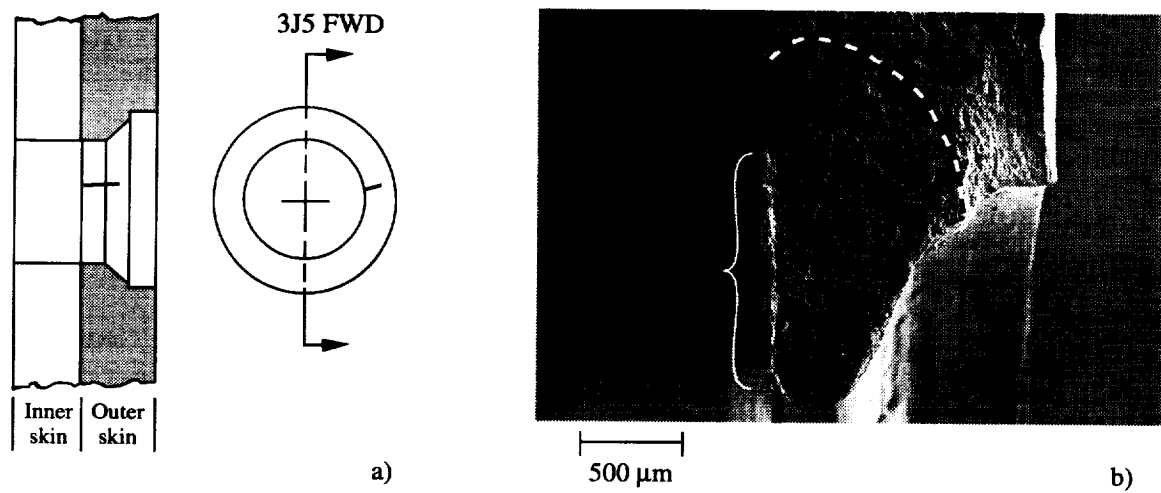
Figure 9.17 a) The schematic shows the rivet hole 3J5 configuration and the location of the outer skin fatigue crack oriented in the forward direction above the 3 o'clock position. b) The SEM micrograph shows the fatigue crack at the rivet hole (bottom). The bracket shows the likely crack initiation region along the faying surface and the dashed line marks the fatigue crack front.

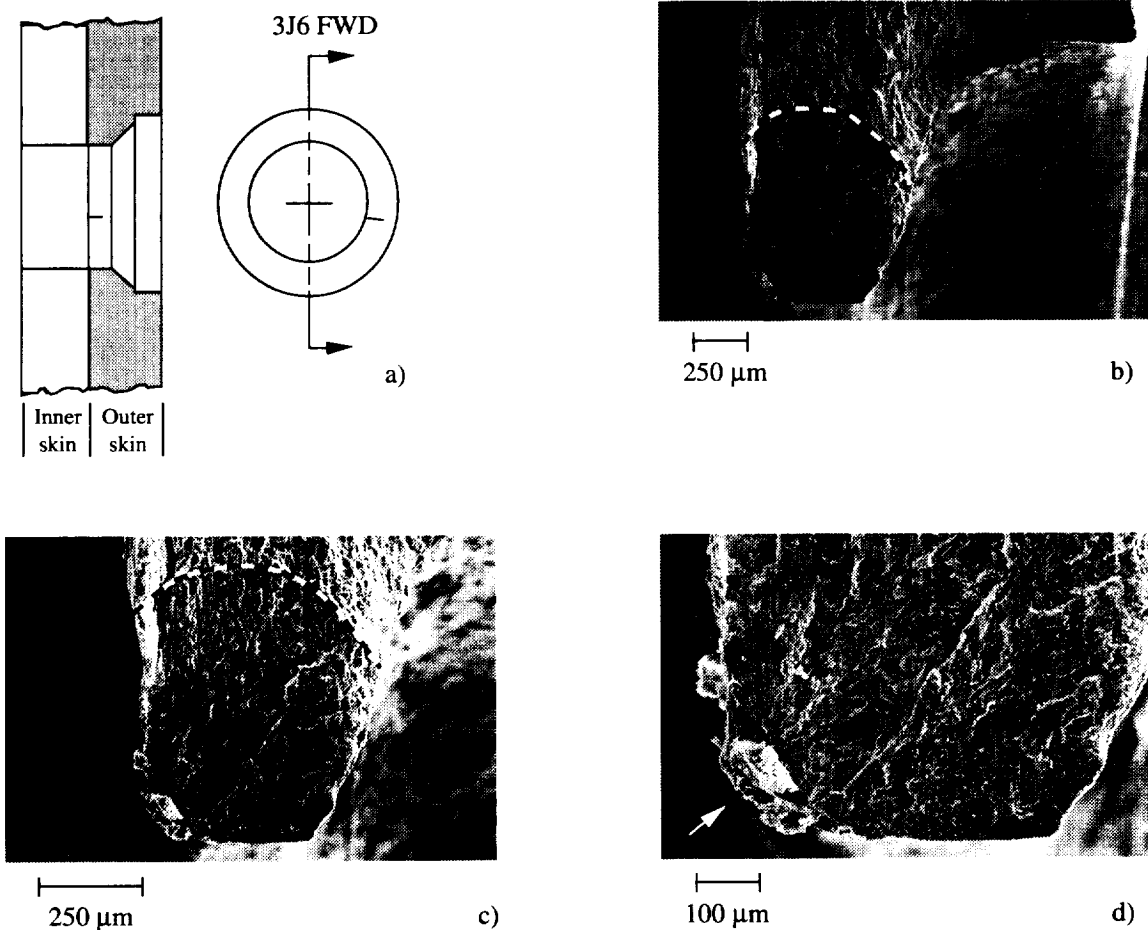
Figure 9.18 a) The schematic shows the rivet hole 3J6 configuration and the location of the outer skin fatigue crack oriented in the forward direction below the 3 o'clock position. b) The SEM micrograph shows the fatigue crack at the rivet hole. The dashed line marks the fatigue crack front. c) The SEM micrograph shows the fatigue crack fracture surface at the rivet hole shank region. The dashed line marks the fatigue crack front. d) The SEM micrograph shows the crack initiation site at the inboard corner of the rivet hole (arrow) at high magnification.

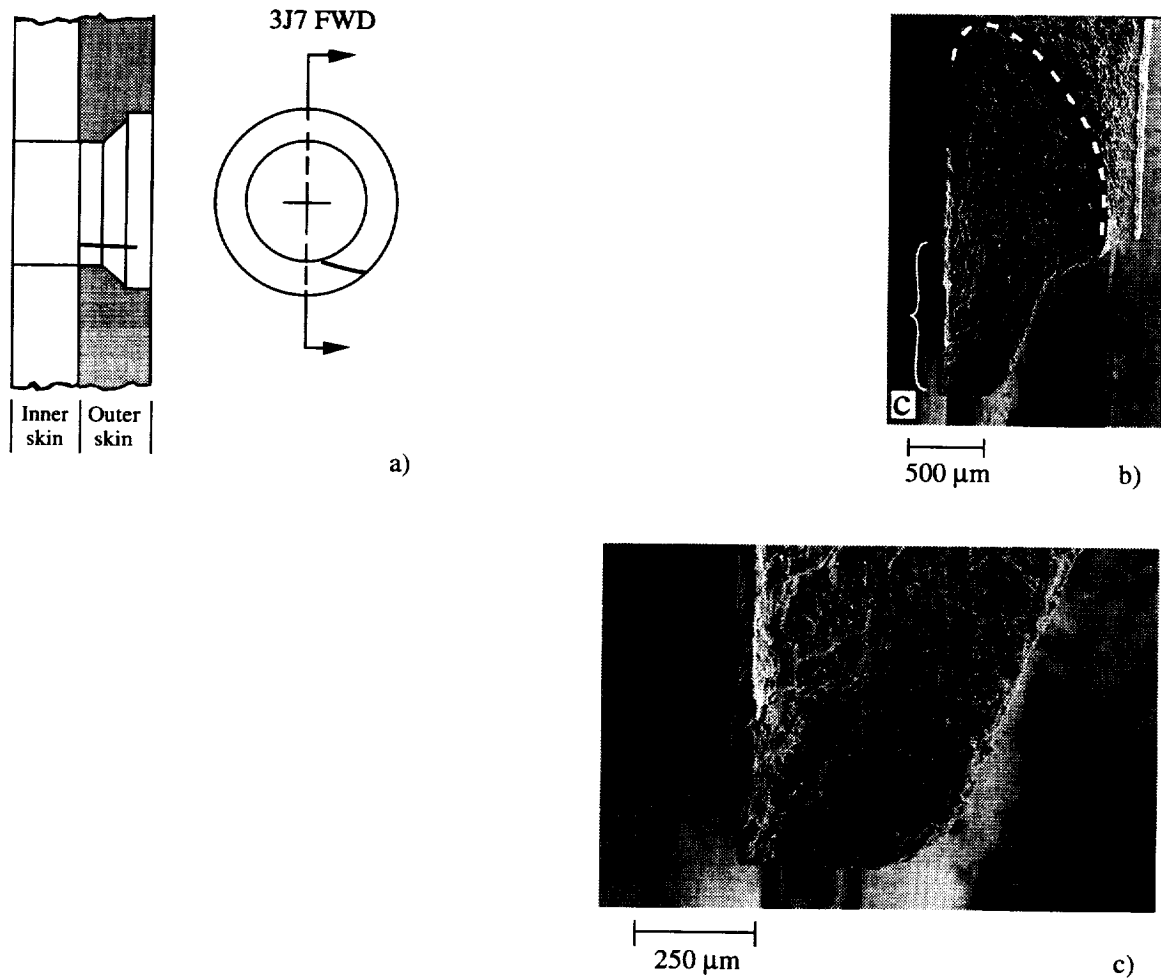
Figure 9.19 a) The schematic shows the rivet hole 3J7 configuration and the location of the outer skin fatigue crack oriented in the forward direction and about the 5 o'clock position. b) The SEM micrograph shows the fatigue crack at the rivet hole (bottom). The bracket shows the likely crack initiation region along the faying surface and the dashed line marks the fatigue crack front. c) The SEM micrograph shows the fatigue crack fracture surface at the rivet hole shank region.

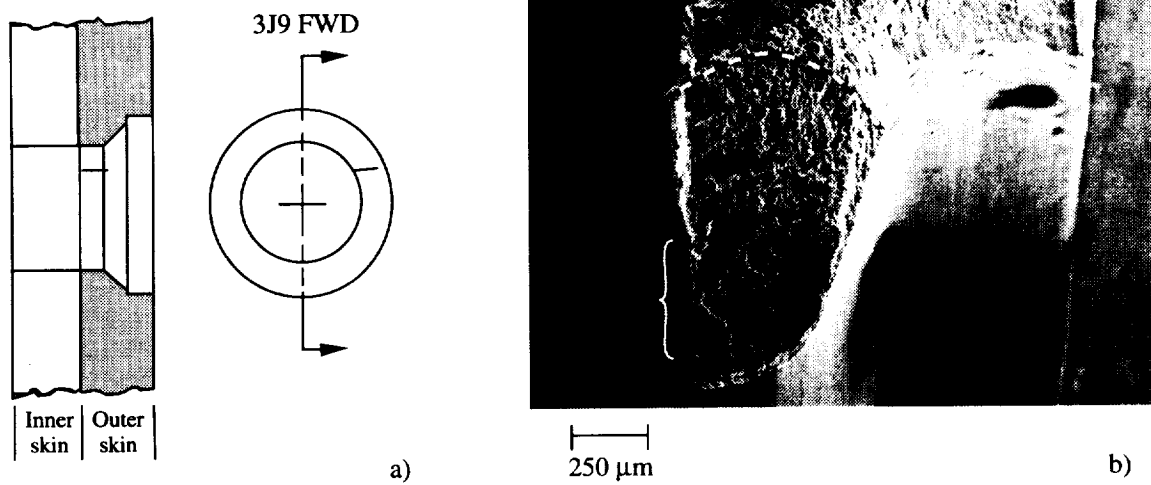
Figure 9.22 a) The schematic shows the rivet hole 3J9 configuration and the location of the outer skin fatigue crack oriented in the forward direction and about the 2 o'clock position. b) The SEM micrograph shows the fatigue crack at the rivet hole (bottom). The bracket shows the likely crack initiation region along the faying surface and the dashed line marks the fatigue crack front.

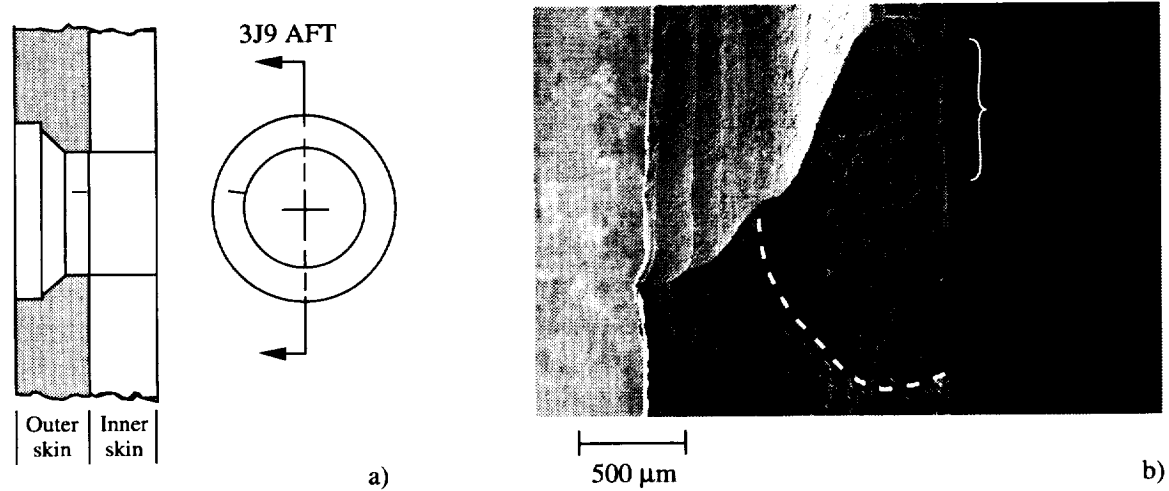
Figure 9.23 a) The schematic shows the rivet hole 3J9 configuration and the location of the outer skin fatigue crack oriented in the aft direction above the 9 o'clock position. b) The SEM micrograph shows the fatigue crack at the rivet hole (top). The bracket shows the likely crack initiation region along the faying surface and the dashed line marks the fatigue crack front.

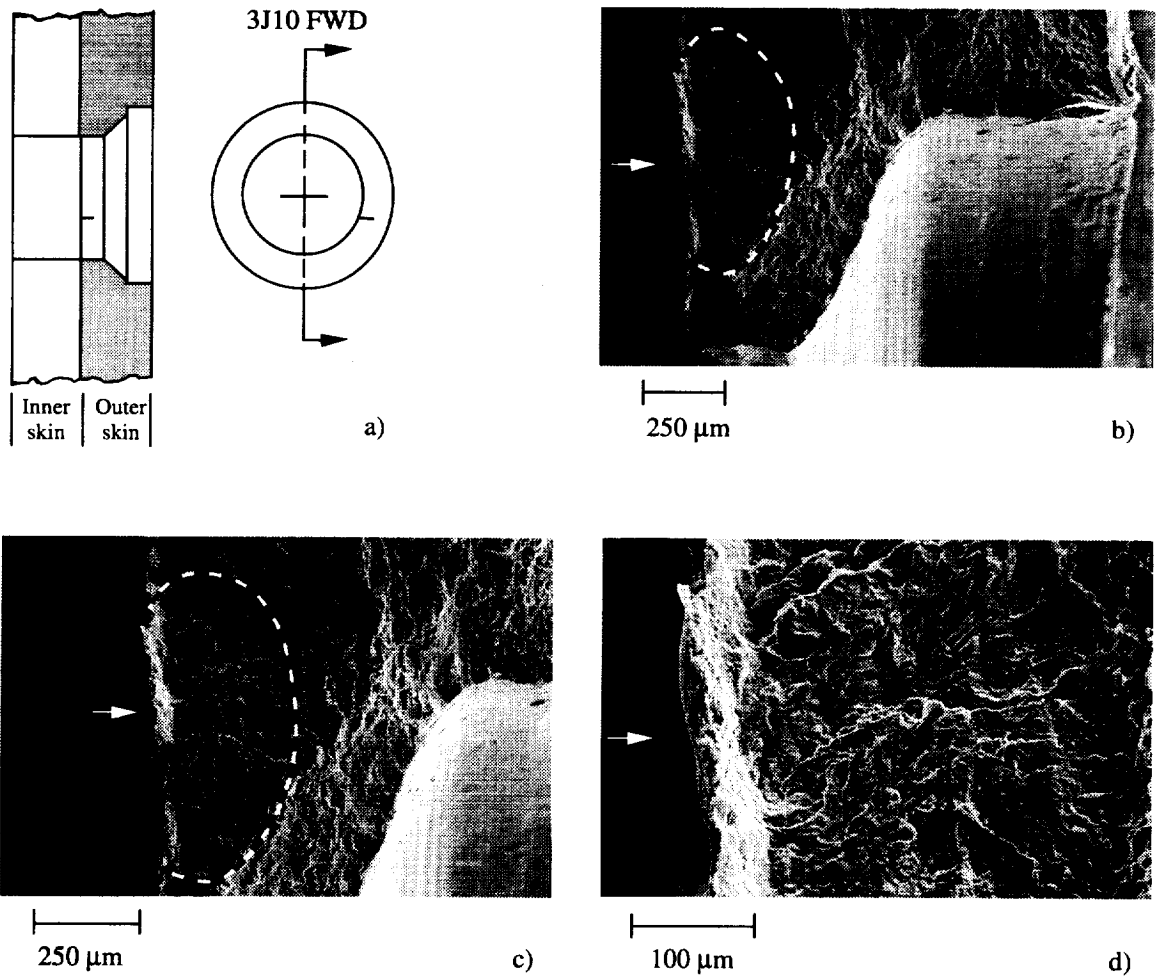
Figure 9.24 a) The schematic shows the rivet hole 3J10 configuration and the location of the outer skin fatigue crack oriented in the forward direction and about the 4 o'clock position. b) The SEM micrograph shows the faying surface fatigue crack at the rivet hole (bottom). The arrow identifies the likely crack initiation region along the faying surface and the dashed line marks the fatigue crack front. c) The SEM micrograph shows the faying surface fatigue crack fracture surface and the region of crack initiation (arrow). d) The SEM micrograph shows the rough faying surface at the site of crack initiation (arrow).

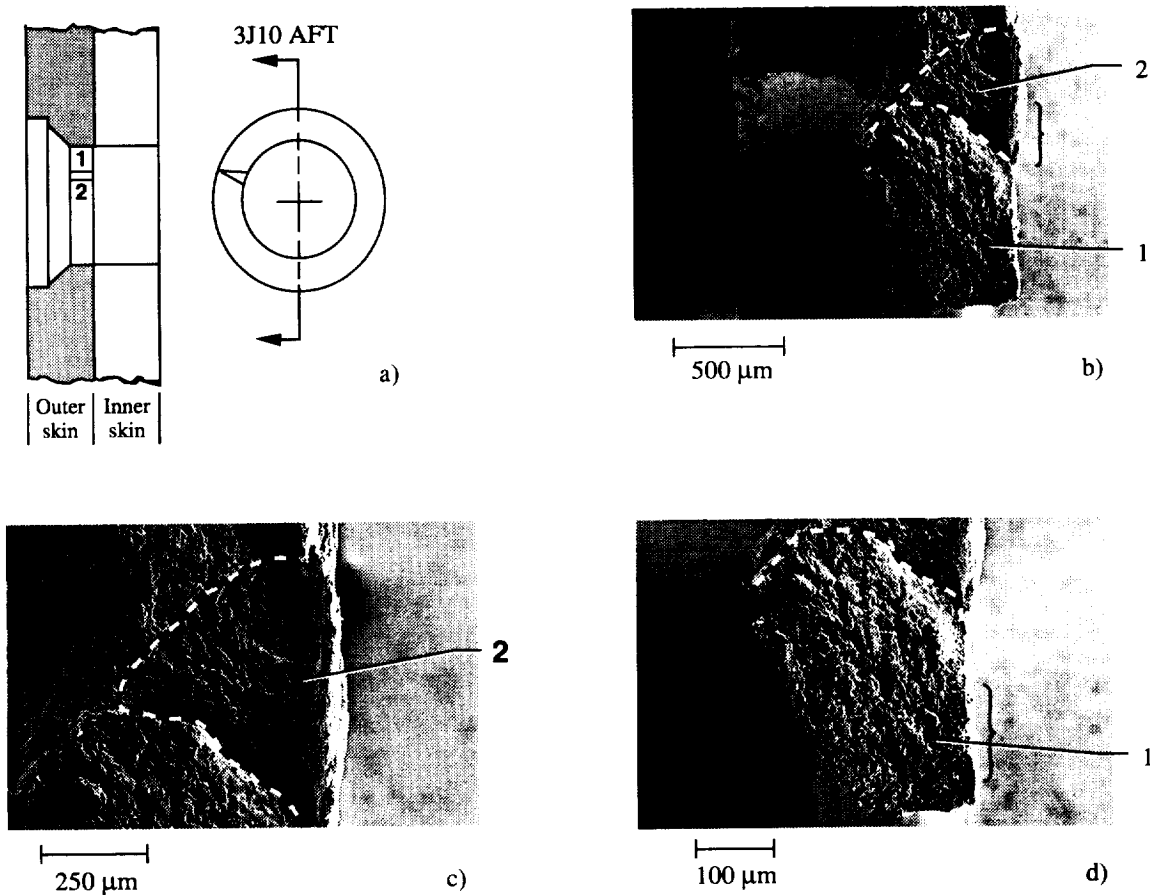
Figure 9.25 a) The schematic shows the rivet hole 3J10 configuration and the location of two outer skin fatigue cracks (1 and 2) oriented in the aft direction and about the 10 o'clock position. b) The SEM micrograph shows the fatigue crack at the rivet hole (bottom). The micrograph reveals that cracking occurred along two fracture planes (1 and 2). A bracket marks the likely crack initiation region for crack "2" along the faying surface and the region where the two cracks coalesced. The dashed line marks the fatigue crack front. c) The SEM micrograph shows the fatigue crack surface at the region of crack "2" shown in Figure 9.25.b. The dashed lines mark the fatigue crack front and the region where the two crack planes linked. d) The SEM micrograph shows the fatigue crack surface at the rivet hole shank and crack "1" in Figure 9.25.b. The bracket marks the likely region of crack initiation for crack "1".

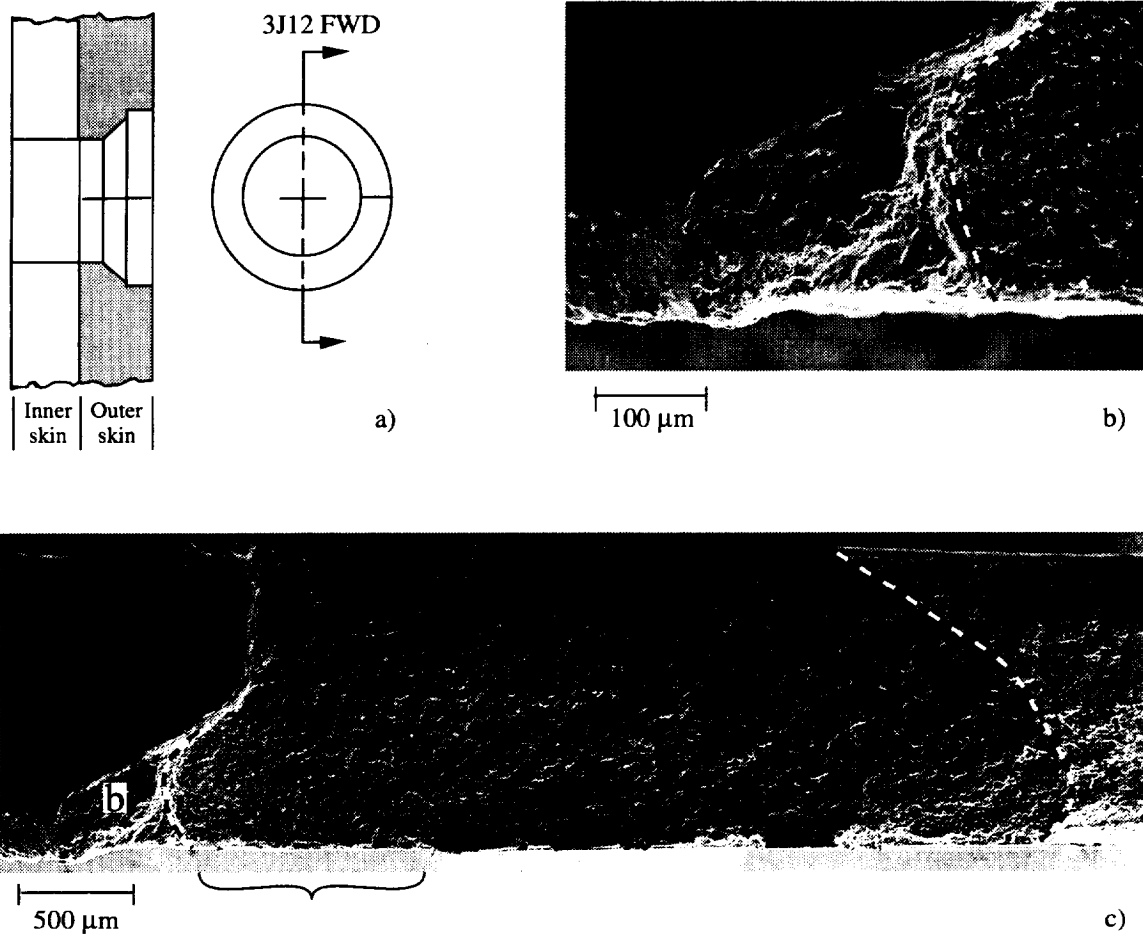
Figure 9.27 a) The schematic shows the rivet hole 3J12 configuration and the location of the outer skin fatigue crack oriented in the forward direction and about the 3 o'clock position. b) The SEM micrograph shows the fatigue crack surface at the rivet hole shank region "b" in Figure 9.27.c. The dashed line marks the fatigue crack front; to the right of the dashed line is the transgranular fatigue crack fracture surface and to the left is a region (ligament) that exhibits a ductile tearing morphology. c) The SEM micrograph shows the fatigue crack fracture surface extending from the rivet hole (left). The bracket marks the likely region of crack initiation along the faying surface and the dashed lines mark the fatigue crack fronts. Presumably, the crack initiated at a site located a considerable distance from the rivet hole, forming a ligament that failed by ductile tearing.

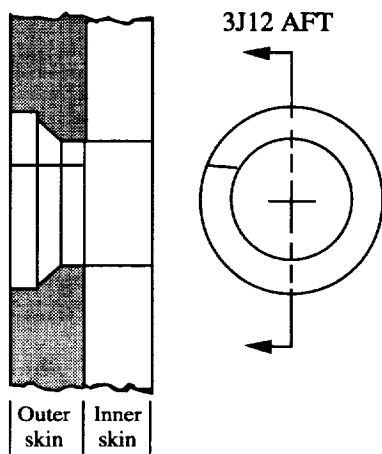
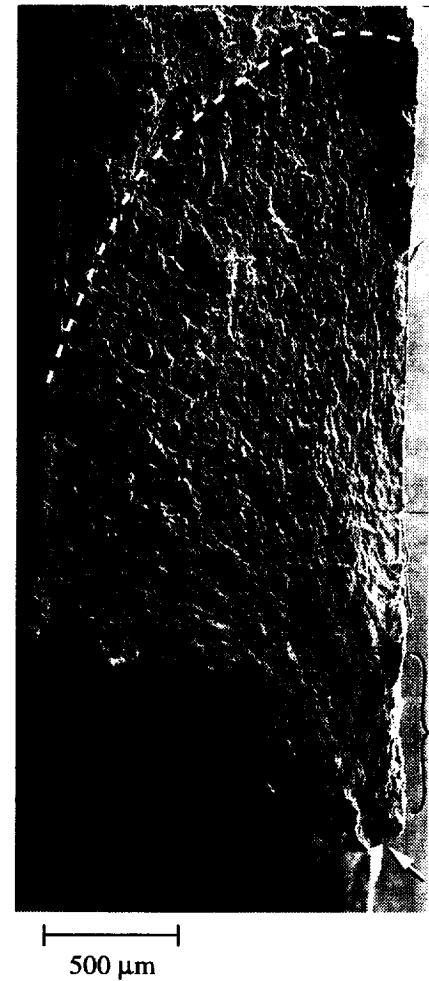
Figure 9.28 a) The schematic shows the rivet hole 3J12 configuration and the location of the outer skin fatigue crack oriented in the aft direction and about the 10 o'clock position. b) The SEM micrograph shows the fatigue crack fracture surface extending from the rivet hole (bottom). The arrow and bracket mark the likely regions of crack initiation at the inboard corner and faying surface of the rivet hole and the dashed line marks the fatigue crack front.

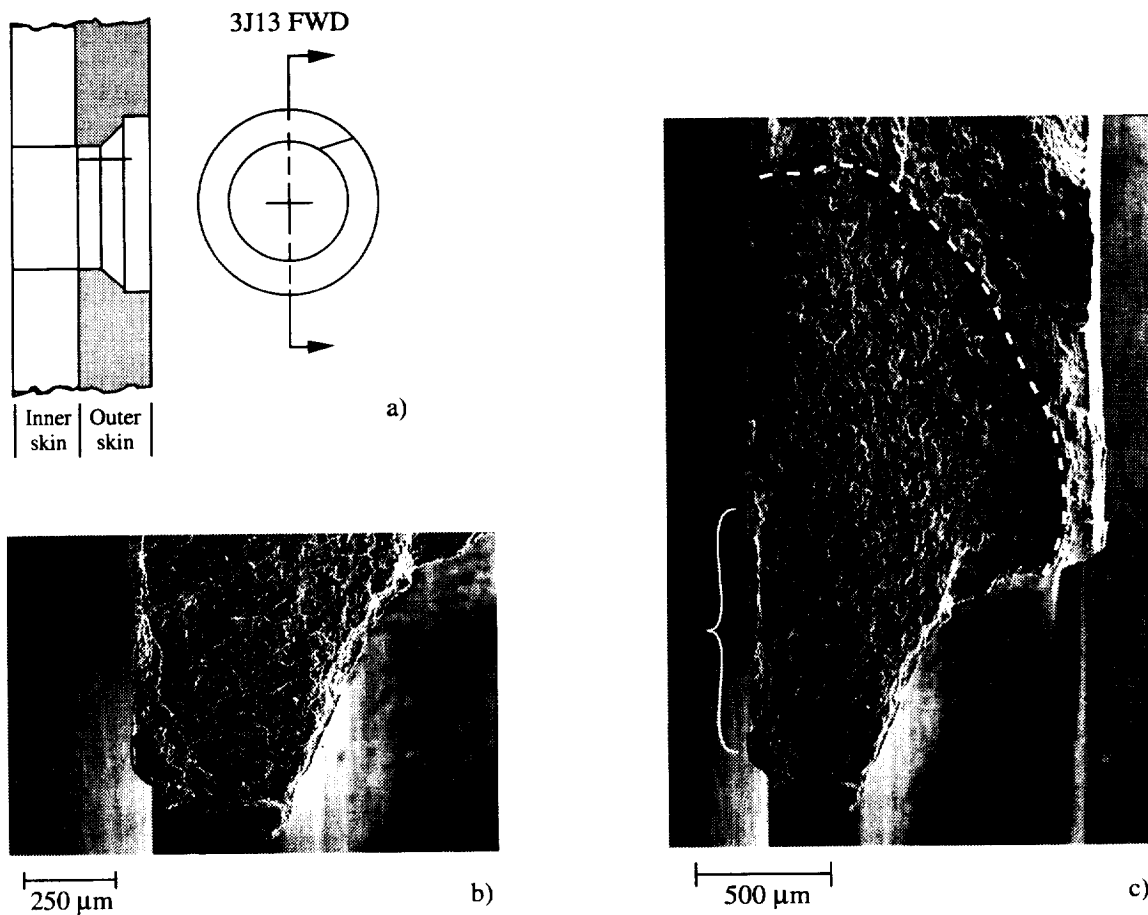
Figure 9.29 a) The schematic shows the rivet hole 3J13 configuration and the location of the outer skin fatigue crack oriented in the forward direction and about the 1 o'clock position. b) The SEM micrograph shows the fatigue crack surface at the rivet hole shank region c) The SEM micrograph shows the fatigue crack fracture surface extending from the rivet hole (bottom). The bracket marks the likely region of crack initiation along the faying surface and the dashed line marks the fatigue crack front.

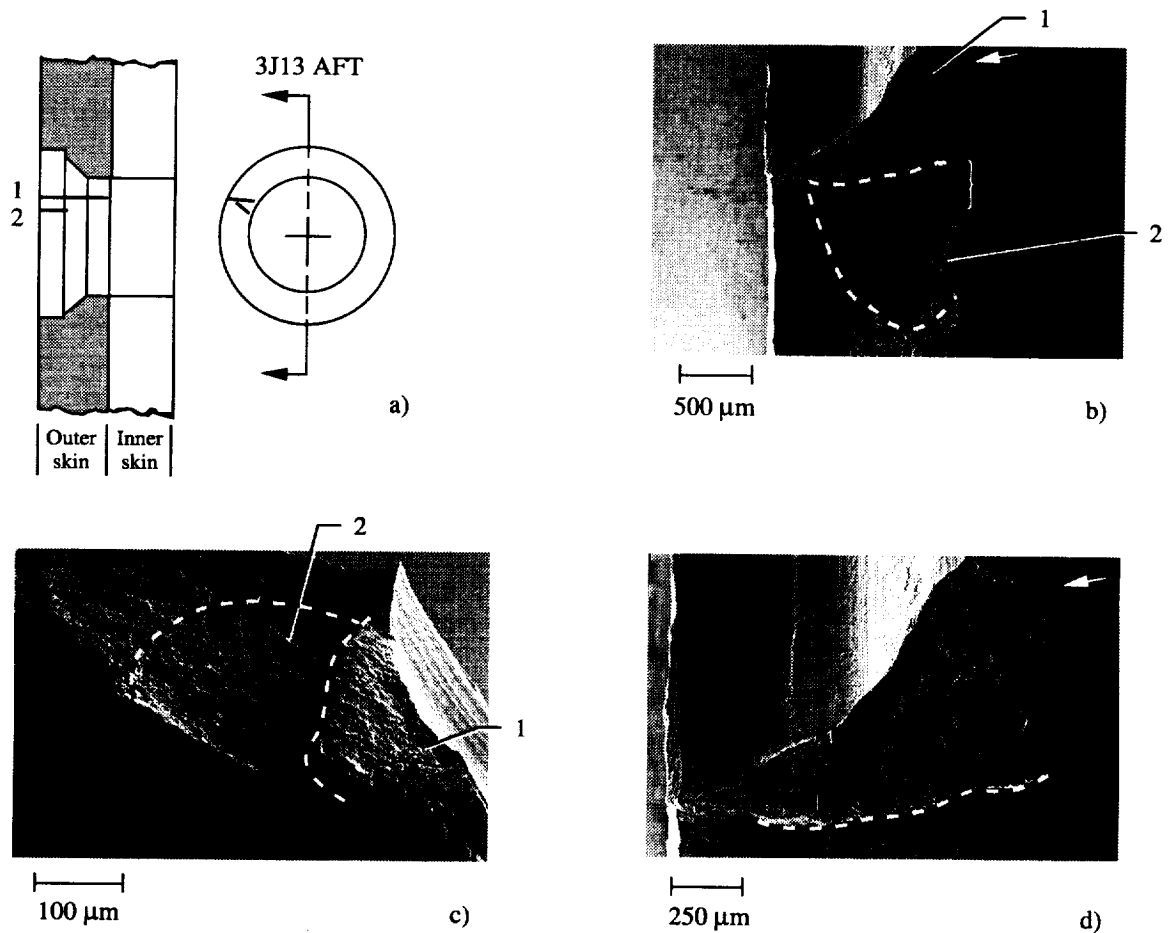
Figure 9.30 a) The schematic shows the rivet hole 3J13 configuration and the location of two outer skin fatigue cracks (1 and 2) oriented in the aft direction and about the 10 o'clock position. b) The SEM micrograph shows the fatigue crack at the rivet hole (top). The micrograph reveals that cracking occurred along two fracture planes (1 and 2). The brackets and arrow mark the likely crack initiation region for cracks "2" and "1", respectively, along the faying surface. The nearly horizontal dashed line near the middle of the fracture surface marks the region where both cracks coalesced. The dashed line extending to the bottom of the micrograph marks the final fatigue crack front. c) The SEM micrograph shows the fatigue crack surfaces of cracks "1" and "2" at an oblique angle. The dashed line on the left marks the final fatigue crack front. The near vertical dashed line marks the region where the cracks coalesced. d) The SEM micrograph shows the fatigue crack surface at the rivet hole shank and crack "1" in Figure 9.25.b. The arrow marks the site of crack initiation.
